# Cleaning of Intersleek<sup>®</sup> using Caviblaster Equipment at HMS Naval Base Devonport

05/08/2009  
Trevor Solomon

Trevor Solomon, Intersleek Senior Product Manager

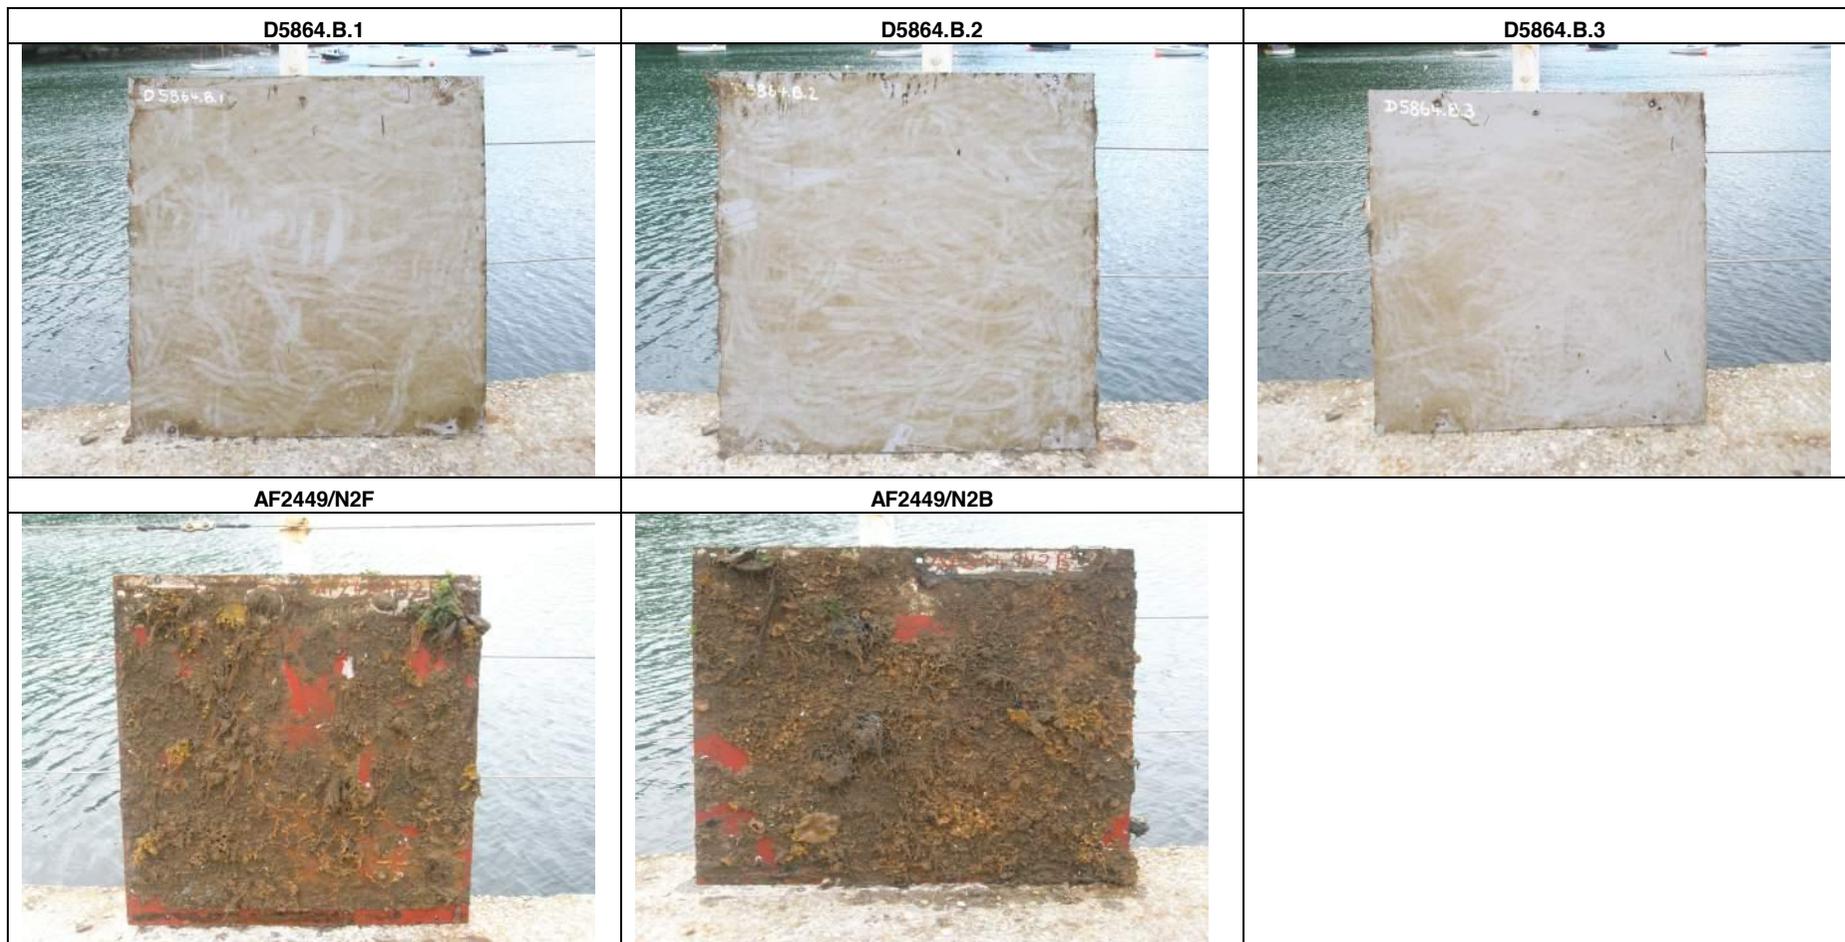
Panels D5864.B.1, 2 and 3 all had a light biofilm.

Panels AF2449/N2F and B had heavy coverage of various fouling organisms (bryozoan, sponges, hydroids, tubeworms, barnacles, muscles and limpets).

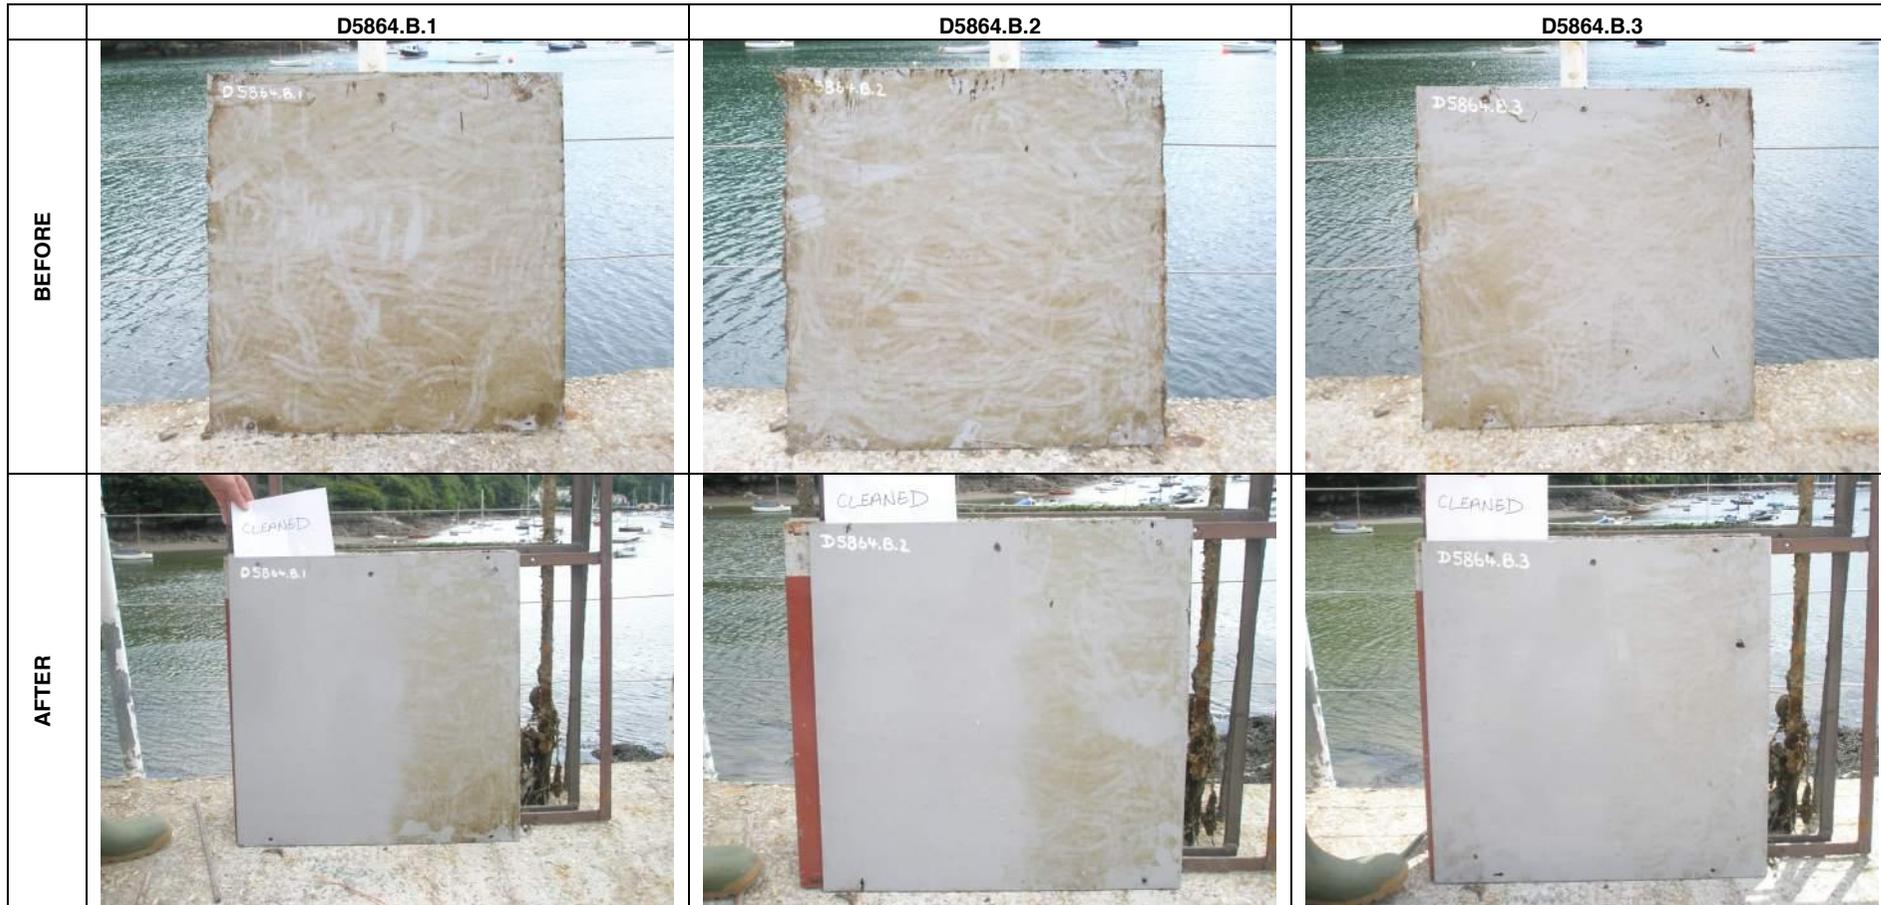
Unsurprisingly, the Caviblaster equipment was slow and struggled with removing the biofilm. However, with practice and through making slower and more passes, the diver was able to remove more of the biofilm. At the speeds necessary though, everyone agreed that this would not be a commercial option for removal.

As each panel was cleaned, the half of the panel cleaned was visually assessed for any signs of damage; none could be found.

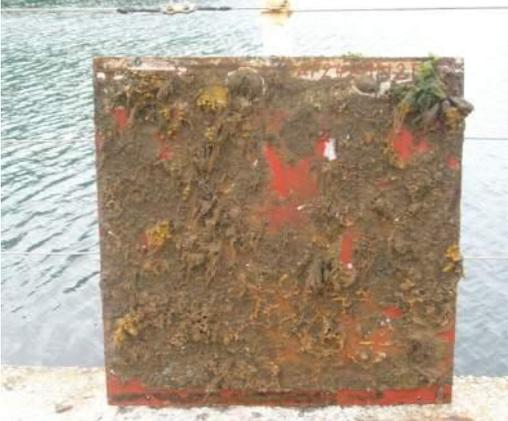
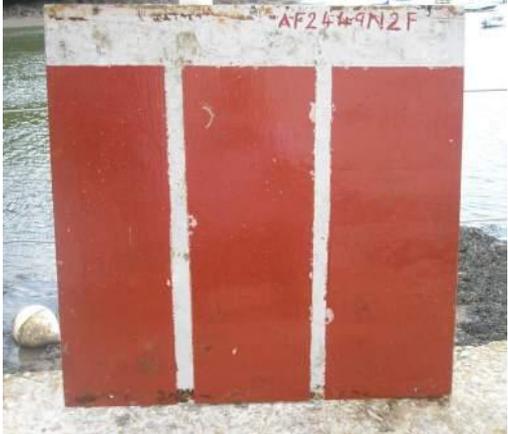
AF2449/N2F	AF2449/N2B
<b>BEFORE</b>

The fouling removal from these panels was very quick, due in part to the ability of the Intersleek® systems to inhibit strength of adhesion of fouling and the equipment itself.

Though not measured, it is estimated that one panel was cleaned in less than 20 seconds.

After cleaning, the panels were visually assessed for damage; as previously, none could be found that could be attributed to the cleaning equipment.

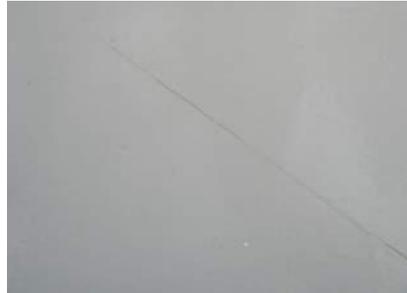
As the Caviblaster equipment appeared unable to damage Intersleek®, a further panel was purposefully scored completely through to the plywood using a knife and the diver was instructed to try and remove the coating. After five minutes, it was apparent that the equipment would not remove any of the coating away from the damage areas.
